Inspection Report

Property Address:
123 Cherry Lane
Anytown OR 99999

HouseGeek

Date: 4/8/2010	Time:	Report ID:
Property: 123 Cherry Lane Anytown OR 99999	Customer: John and Jane Doe	Real Estate Professional:

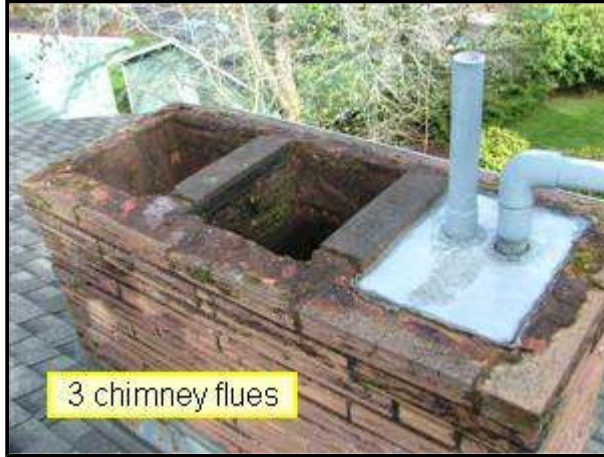
1.2 Picture 1

Chimney with 3 flues: 2 fireplaces and 1 for furnace snorkel and vent.

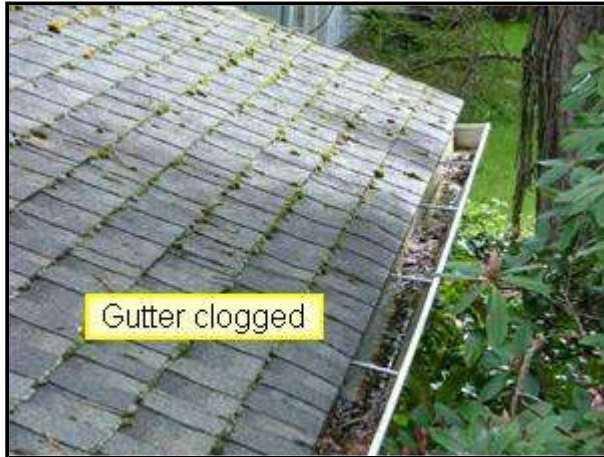
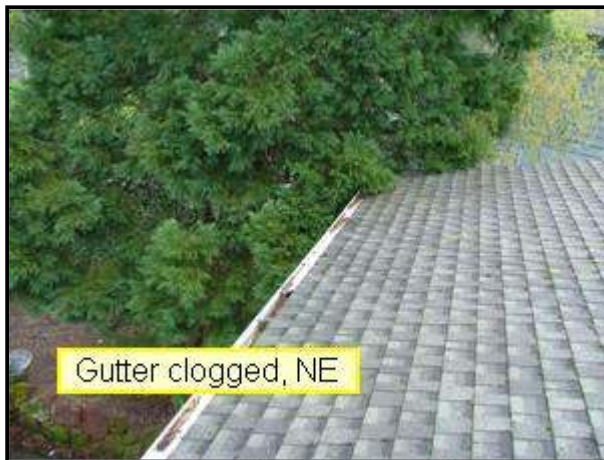
1.3 Picture 1

Gutter clogged on east side in front and back; cleaning recommended.

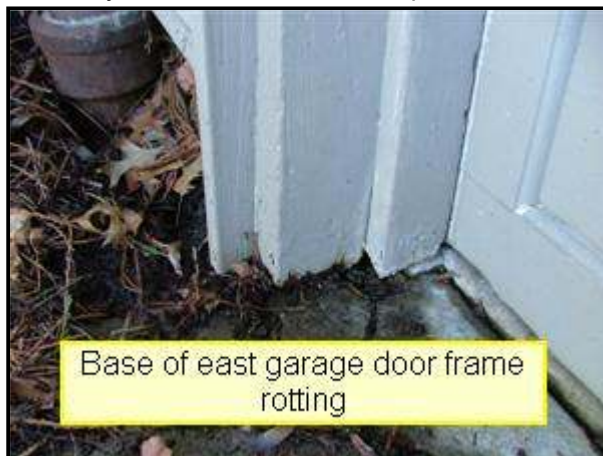
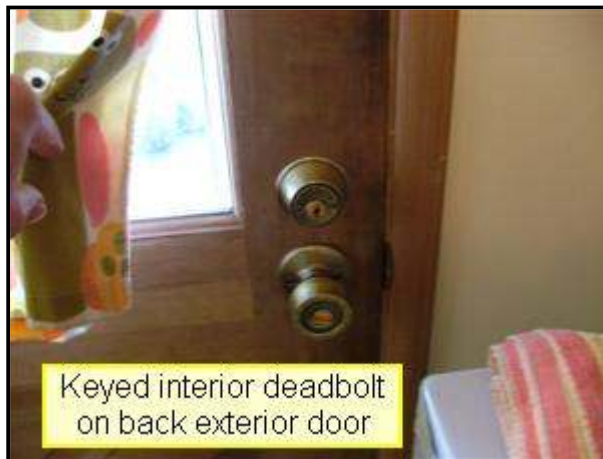
2.1 Picture 1

(1) Base of east-side garage door trim rotting; remove damp material and repair/reseal. Basement exterior door has keyed deadbolt on inside; replace with thumb turn.

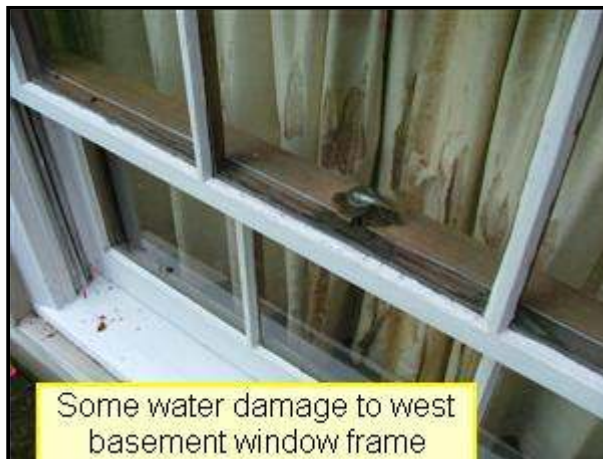
2.2 Picture 1

Some superficial water damage to interior of west-side basement windows.
Paint peeling on small portion of window putty on west-side basement window.

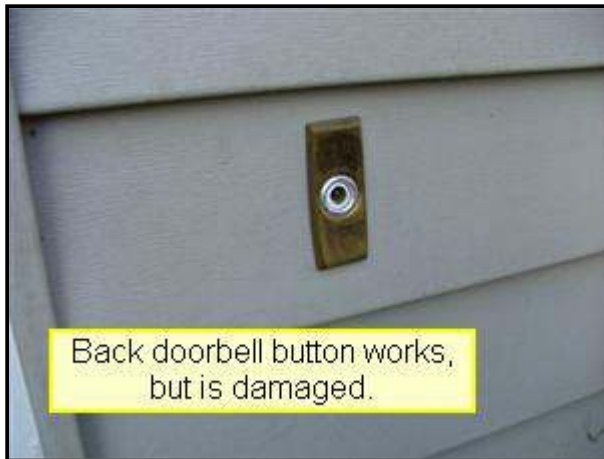
2.6 Picture 1

2.6 OTHER
Comments:
 Back doorbell functions, but button is broken.

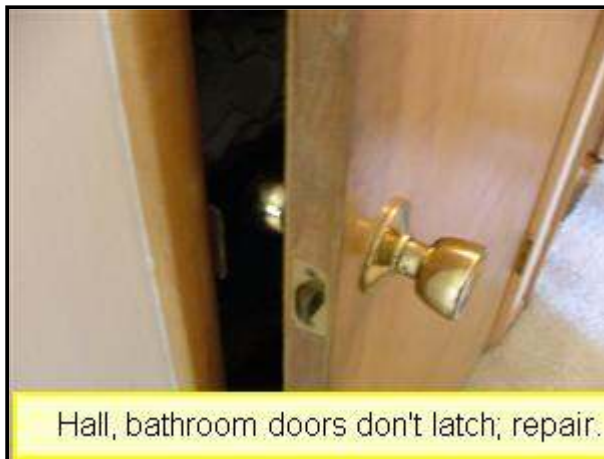
4.5 Picture 2

(2) Upper floor bathroom door and several closet doors don't latch -- should be easy repair.

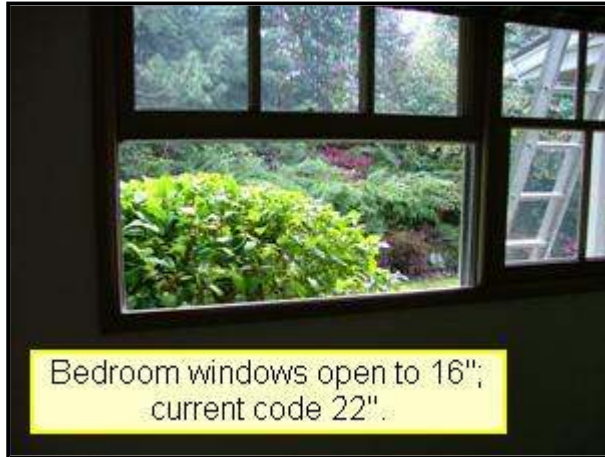
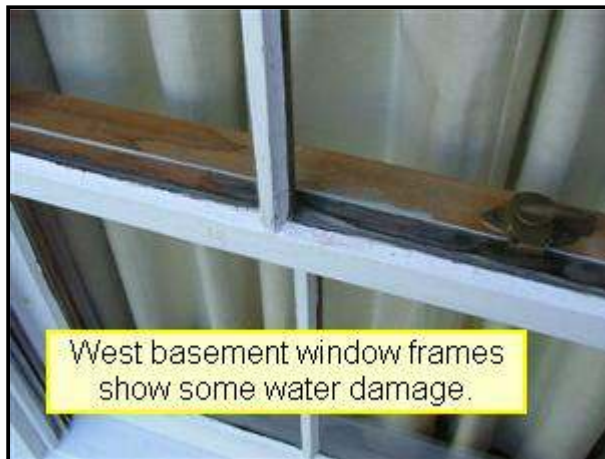
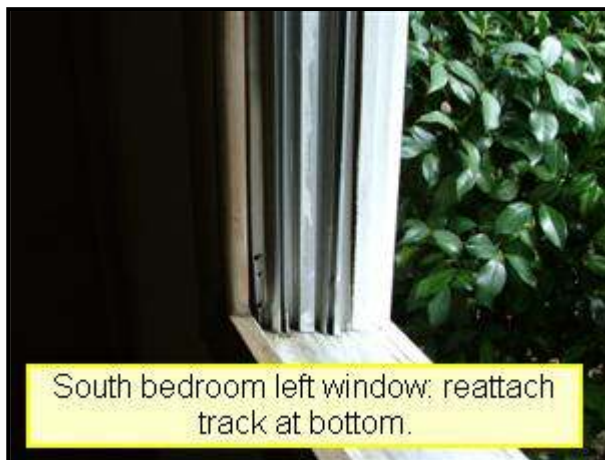
4.6 Picture 1

Bedroom emergency egress windows open to 16" high; current code 22".

West-side basement windows show superficial water damage on interior, possibly from condensation.

South bedroom east window: reattach base of track.

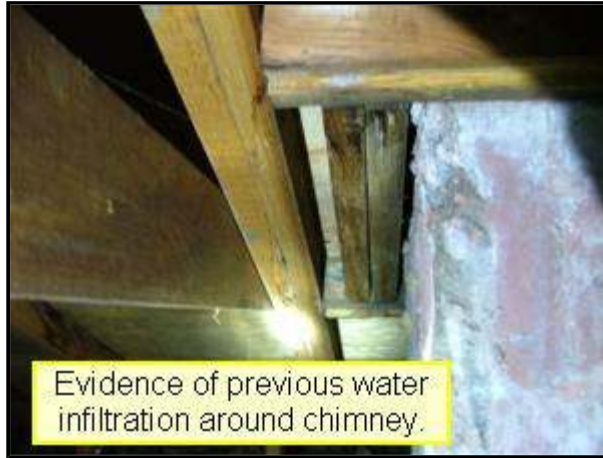
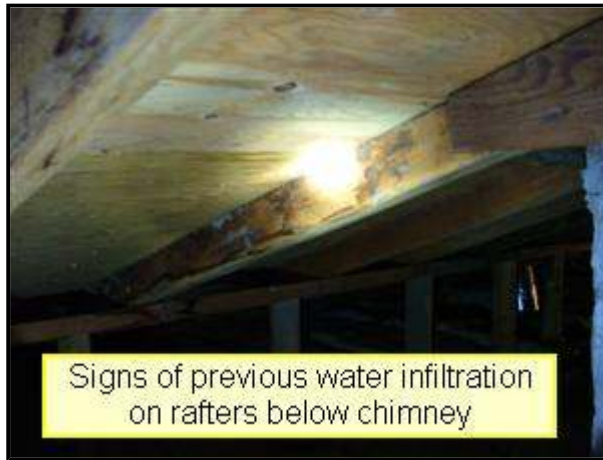
5.5 Picture 1

Signs of prior water infiltration on roof rafters around chimney in attic. Roof sheathing is newer, so this problem was probably addressed.

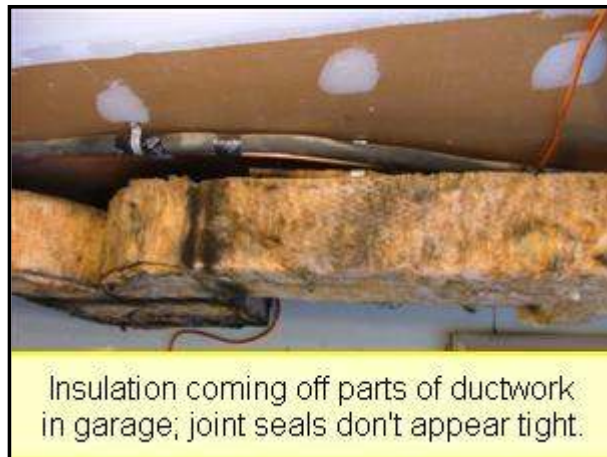
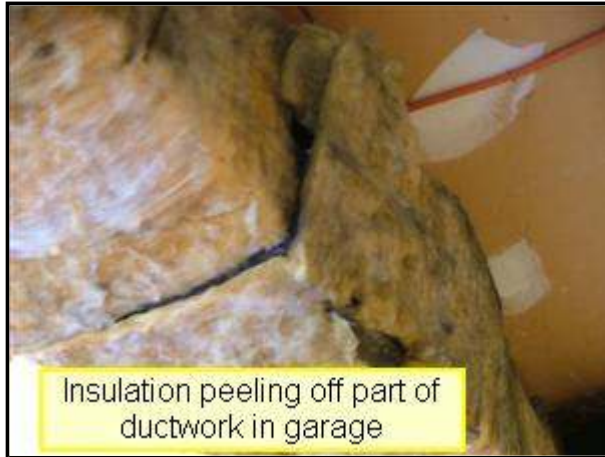
8.3 Picture 1

Heat duct in garage: recommend making sure joints are sealed properly before repairing insulation.

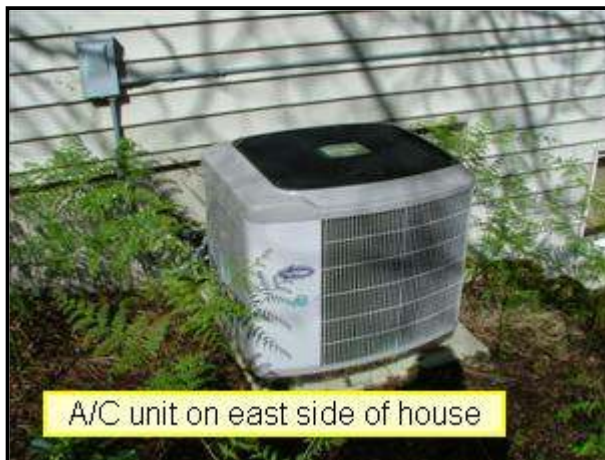
8.8 Picture 1

8.8 COOLING AND AIR HANDLER EQUIPMENT
Cooling Equipment Type: Air conditioner unit
Cooling Equipment Energy Source: Electricity
Central Air Manufacturer: UNKNOWN
Number of AC Only Units: One
Comments:
 Air conditioning unit on east side.

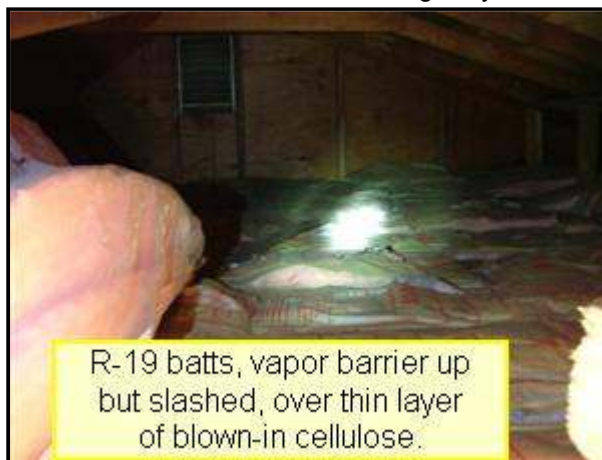
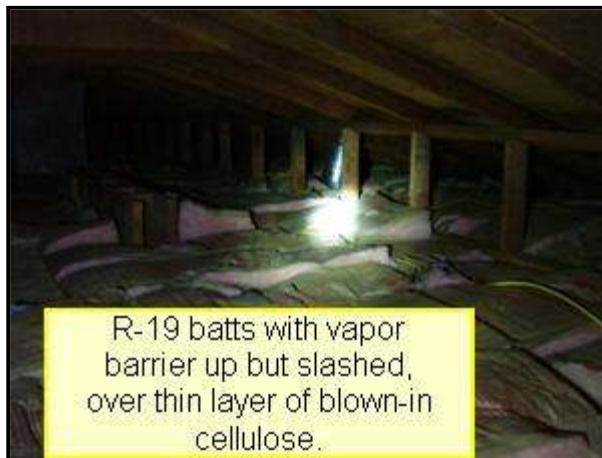
9.0 Picture 1

R-19 fiberglass batts with vapor barrier on top slit open to allow vapor to escape, over thin layer of blown-in cellulose. Ideally, intact R-19 would have been installed with vapor barrier toward heated space, but at least there's more insulation than originally.

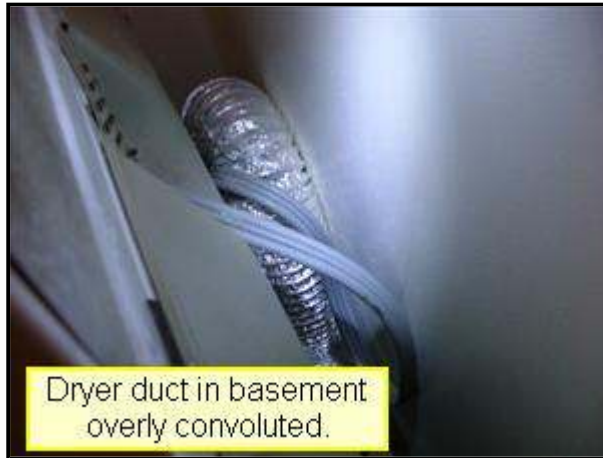
9.4 Picture 1

Dryer duct overly convoluted.

Dryer duct in basement
 overly convoluted.

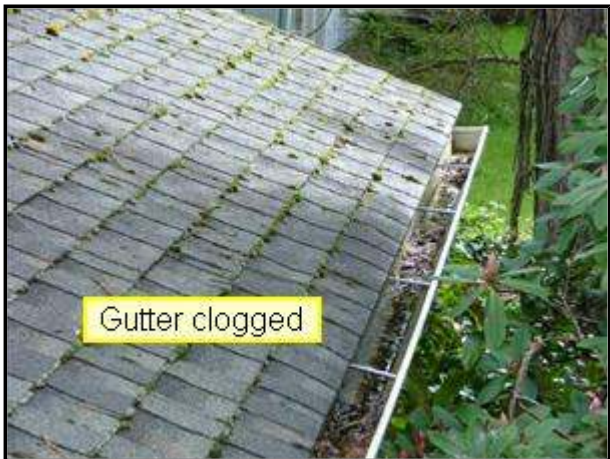
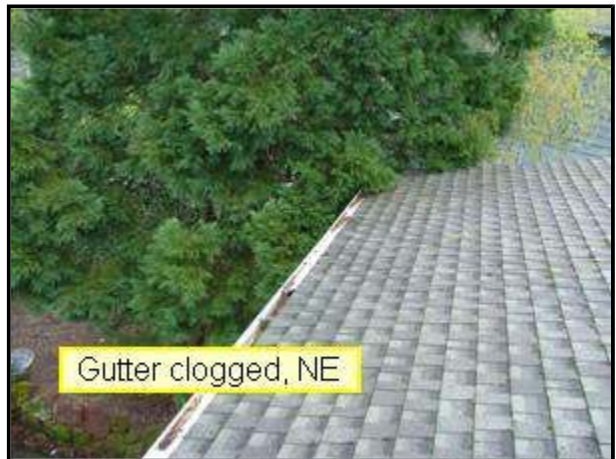
1.3 Picture 1

Gutter clogged on east side in front and back; cleaning recommended.

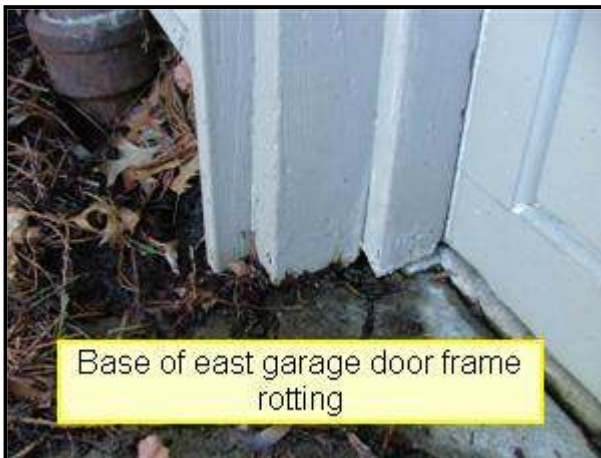
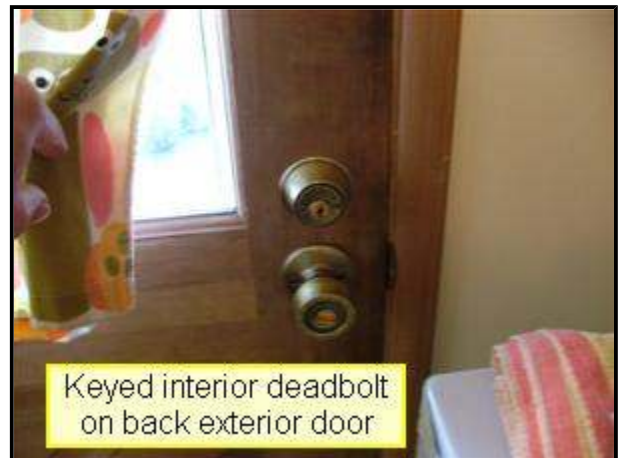
2.1 Picture 1

(1) Base of east-side garage door trim rotting; remove damp material and repair/reseal. Basement exterior door has keyed deadbolt on inside; replace with thumb turn.

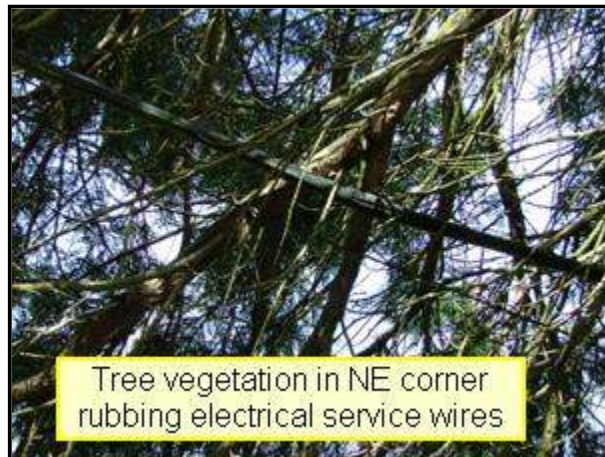
2.4 Picture 1

Tree branches at NE corner of house should be trimmed back -- touch house and put pressure on electrical service cables.

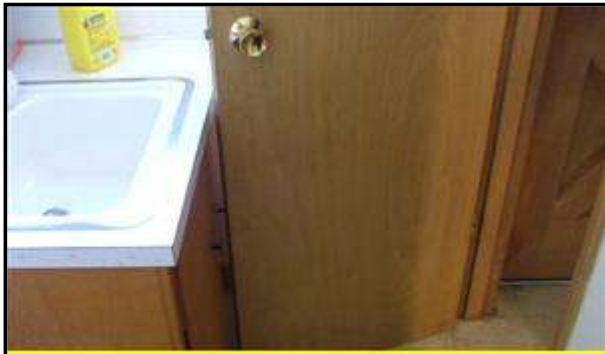
4.5 Picture 1

(1) Basement bathroom door runs into sink cabinet. Sink could be replaced with one less deep so door can open fully.

Basement bath door: replace sink with one less deep so door can swing freely?

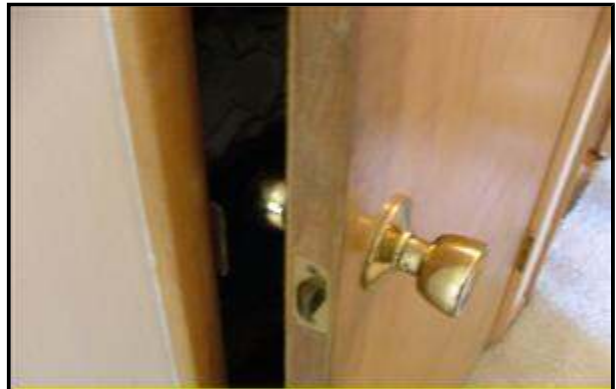
4.5 Picture 2

Hall, bathroom doors don't latch; repair.

(2) Upper floor bathroom door and several closet doors don't latch -- should be easy repair.

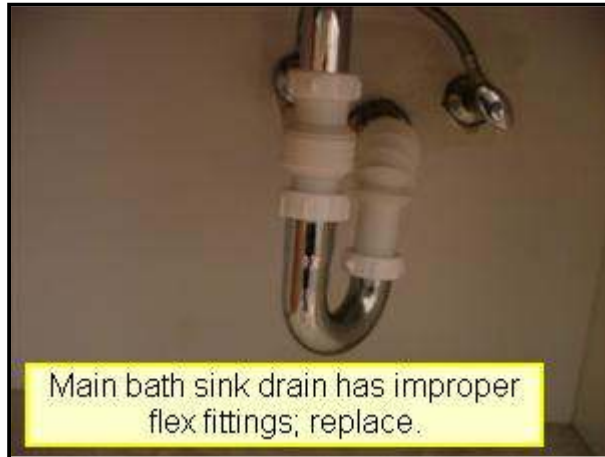
6.0 Picture 3

(2) Main bathroom sink drain has inappropriate drain material; should be replaced with smooth-walled drain fittings.

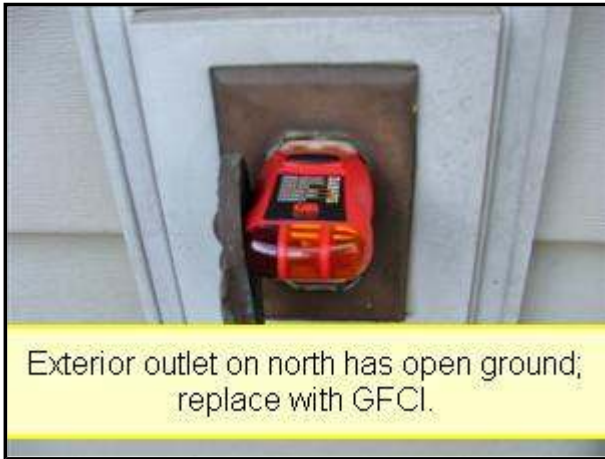
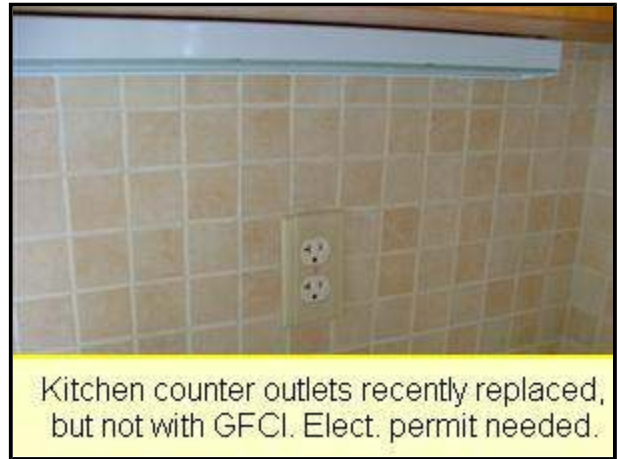
7.4 Picture 1

(1) Kitchen counter outlets have been recently replaced. Should have been replaced with GFCI outlets.

(2) Back exterior outlet is ungrounded. GFCI outlet should be installed.

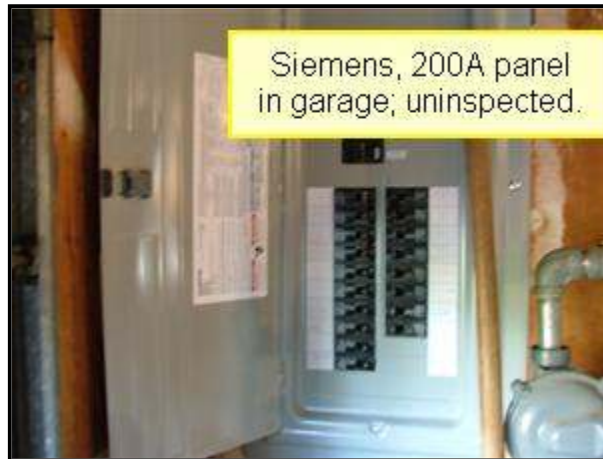
7.6 Picture 1

In garage.
