Inspection Report

Property Address:
123 Cherry Lane
Anytown OR 97999

Date: 3/28/2019	Time: 03:00 PM	Report ID:
Property: 123 Cherry Lane Anytown OR 97999	Customer: John and Jane Doe	Real Estate Professional:

Type of building:
Manufactured home

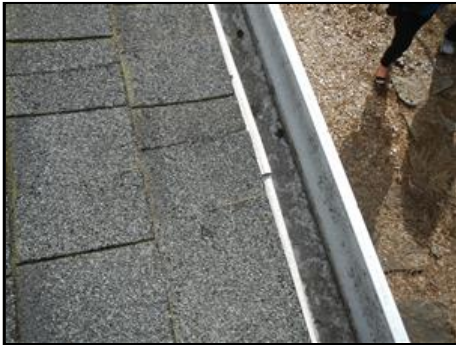
1.1 Flashing into gutters appears to be pulling away from house in a few places. Recommend this be further investigated to make sure storm water is properly directed into gutters and away from house.

1.1 Picture 1 Roof flashing in back

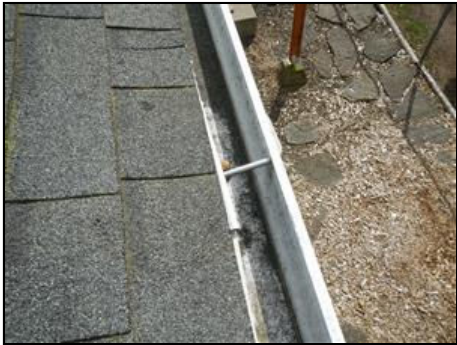
1.1 Picture 2 Roof flashing in back

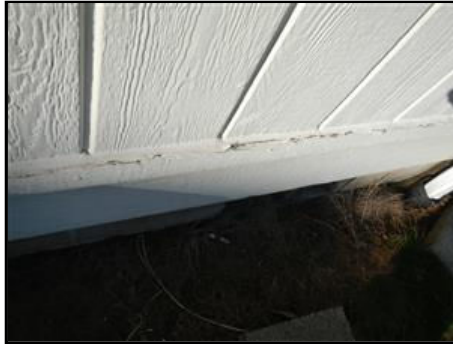
2.0 Paint peeling, sealant failing at top of some trim boards. It's important to keep siding areas maintained, especially where they're in heavy contact with rain, such as trim boards.

2.0 Picture 1 Exterior trim board

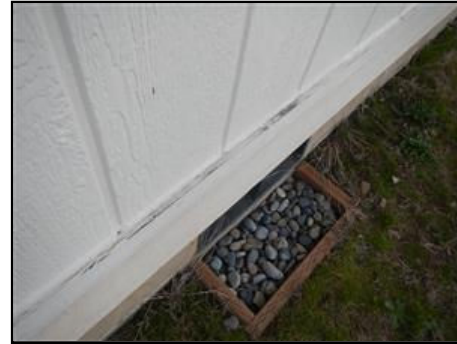
2.0 Picture 2 Paint peeling at top of trim board

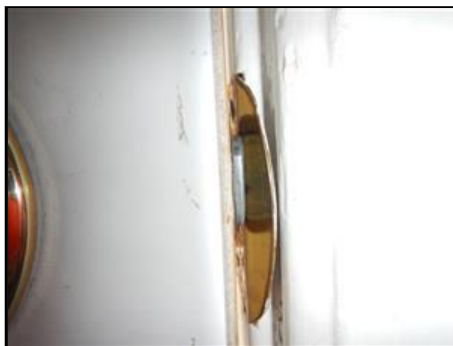
2.1 Back door deadbolt doesn't line up with hole in jamb, so cannot operate.

2.1 Picture 1 Deadbolt too high for strike plate in back door

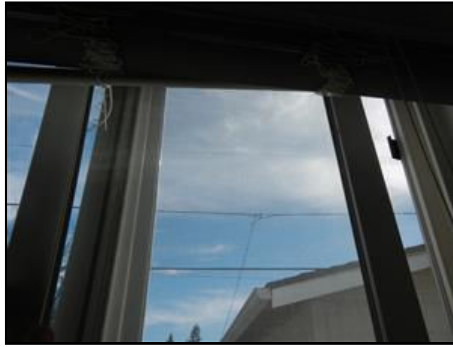
2.2 Note for security: small windows are loose in tracks; can be opened easily from outside if screens are cut.

2.2 Picture 1 Laundry area window loose in track

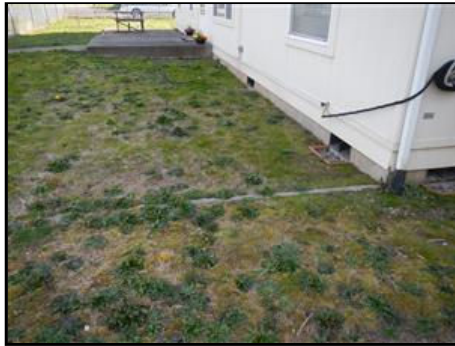
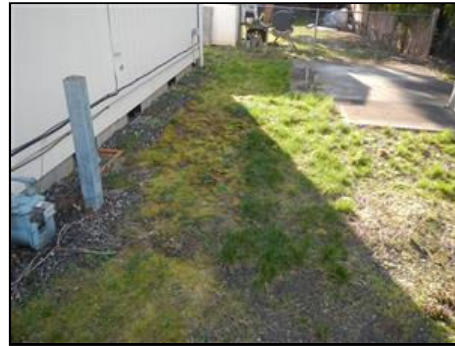
2.4 Land is flat around home. Ideally, it would fall at least 6 inches within 10 feet away from home. It appears ground moisture is entering crawl space, causing moisture damage.

2.4 Picture 1 Ground flat around home

2.4 Picture 2 Ground flat around home

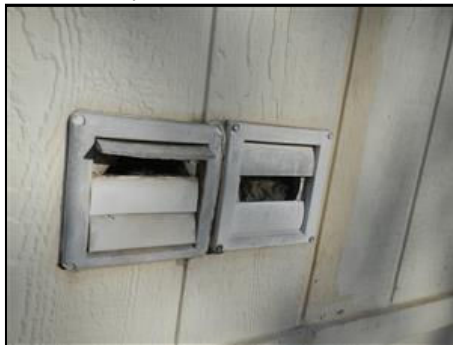
2.6 Dryer duct outlet louvers don't shut all the way, allowing some extra heat to be lost from the house. There appear to be two dryer ducts, with the one on the south plugged by insulation materials. South-side dryer duct could be closed off completely to reduce heat loss.

2.6 Picture 1 Dryer duct outlets

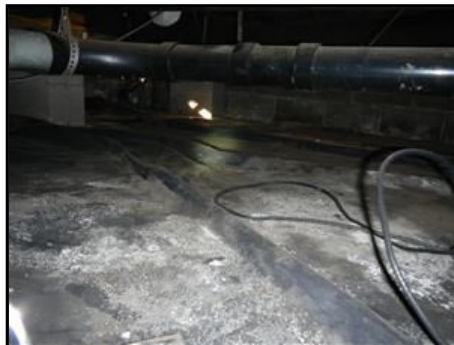
5.0 Water has entered crawl space often in the past; evidence is dried mud left behind on black polyethylene sheet covering ground, heavy efflorescence at bases of concrete block piers and foundation walls, and rusted bases of steel recessed perimeter piers. Because concrete block perimeter foundation wall is continuous, steel recessed perimeter piers aren't required.

Water infiltration may be a result of site grading -- entire site, including under home, is flat. The ground under the home should be sloped away from the center, and that slope should continue to at least 10 feet from home. If the water entry is because of the lack of proper grading or a high water table at the site, perimeter drains or a sump pump could be installed to manage the water. Crawl space was dry and it had not rained in several days at time of inspection, so could not determine if there is a break in a storm water drain pipe routed through crawl space. Regular moisture under a home can cause damage and mold from the high humidity.

5.0 Picture 1 Signs of frequent water entry into crawl space

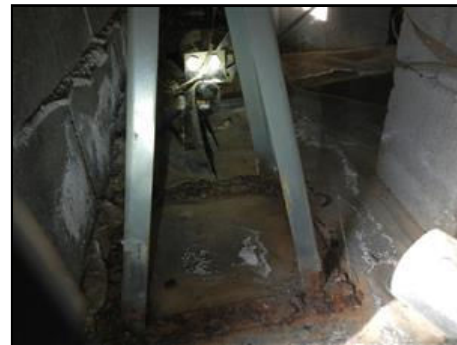
5.0 Picture 2 Rusted base of steel recessed perimeter pier

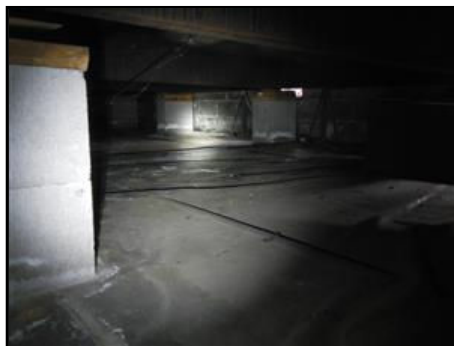
5.0 Picture 3 Efflorescence at bases of concrete block piers

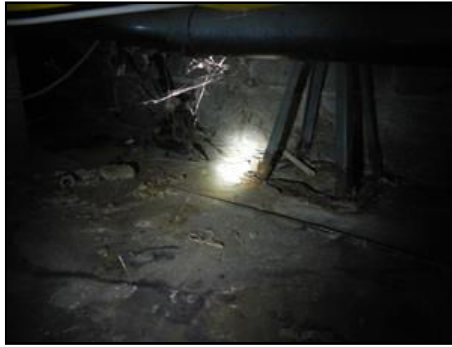
Note: Structure is tied down to earth with ground anchors.

5.0 Picture 5 Ground anchor to left of recessed perimeter pier

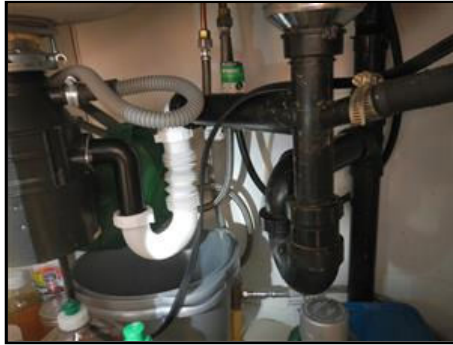
6.0 Picture 1

6.0 Garbage disposal not plumbed properly; dishwasher drain hose doesn't enter disposal, it's double-trapped, and it has a corrugated waste pipe. Recommend repair by licensed plumbing contractor.

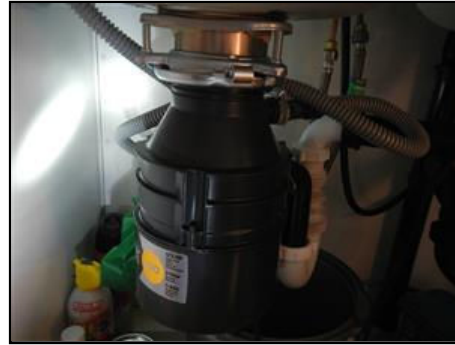
6.0 Picture 2 Garbage disposal with capped-off dishwasher drain hose attached

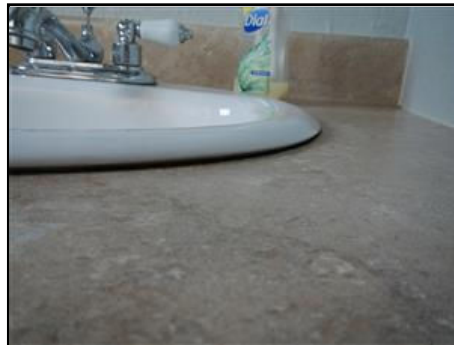
6.1 Picture 1 Sealant missing where bathroom sink meets counter

6.1 Recommend sealant between bathroom sinks and countertop so water doesn't deteriorate counters.

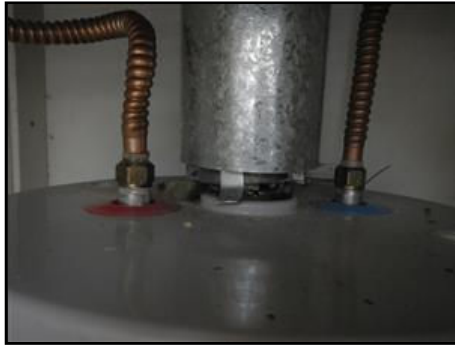
6.2 Flue not attached to water heater, and hood not present (water heater replaced after 2006). Recommend evaluation and service by licensed plumbing or HVAC contractor that works on water heaters.

6.2 Picture 1 Hot water heater flue not attached

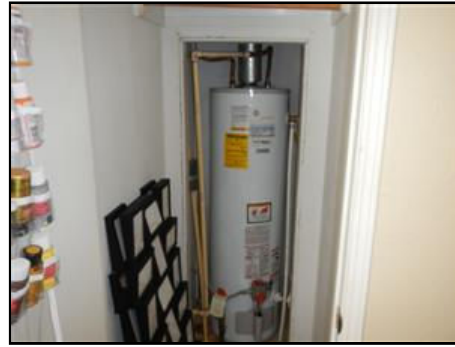
Gas water heater is in concealed alcove in closet in NW room. There is not enough combustion air provided. Recommend evaluation and service by HVAC contractor.

6.2 Picture 2 Water heater in alcove inside closet

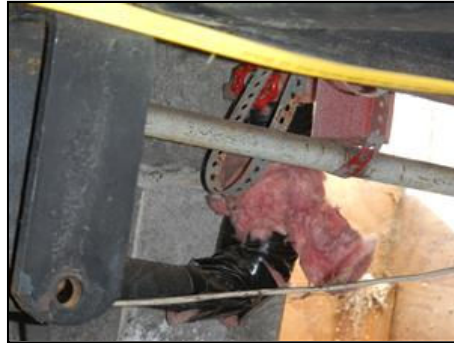
6.3 Main water shut-off valve is a red-handle valve just inside crawl space entrance

6.3 Picture 1 Red-handled main water shutoff
inside crawl space

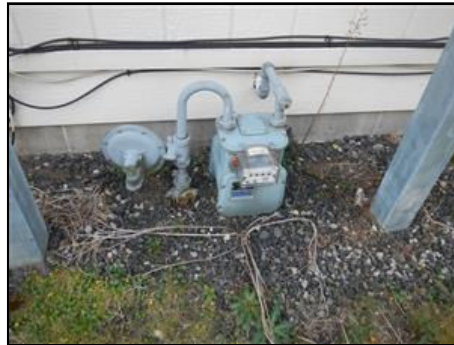
6.5 Main fuel shut-off valve is at base of gas meter on north side of house.

6.5 Picture 1 Gas meter on north side

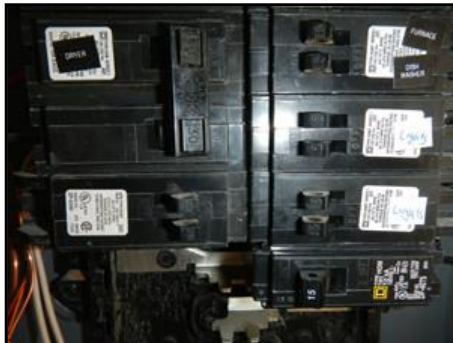
7.1 Label missing for newer 15-amp breaker in lower-right corner of sub-panel inside home.

7.1 Picture 1 No identification for breaker in lower right

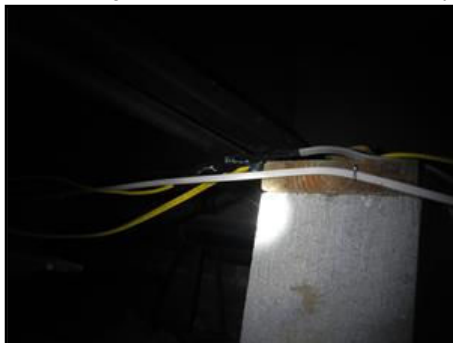
7.2 Wires spliced improperly in crawl space; yellow-colored NM cable spliced to white-colored UF cable that enters conduit to exterior at back of house. Recommend further investigation to see if this circuit is necessary; might be able to be removed.

7.2 Picture 1 Improper wire splice in crawl space

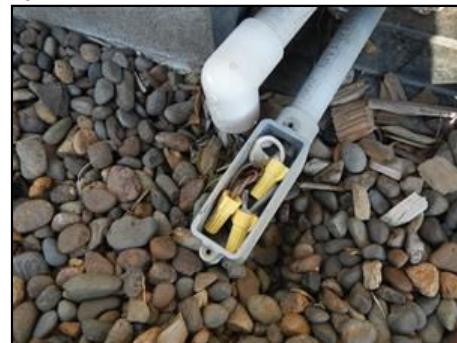
7.2 Picture 2 Conduit from crawl space at back of house (pull box cover removed)

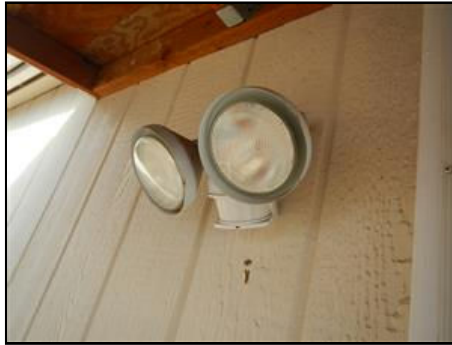
7.3 Was not able to successfully operate light at back door. May be burnt-out bulbs.

7.3 Picture 1 Back door light

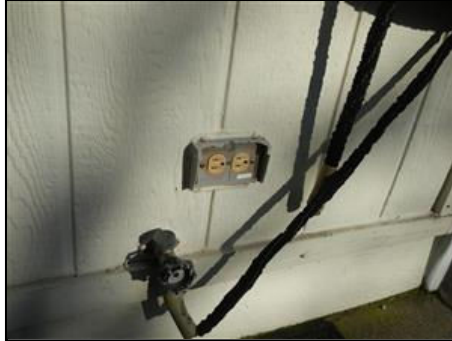
7.4 Exterior receptacle to the south of back door does not appear to have power and may lack GFCI protection. Weatherproof cover missing.

7.4 Picture 1 Receptacle to south of back door

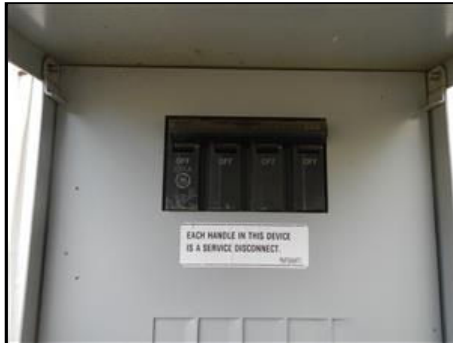
7.6 Main panel is at meter on the north side exterior. Sub-panel is in utility room inside back door.

7.6 Picture 1 Main breaker at exterior meter panel

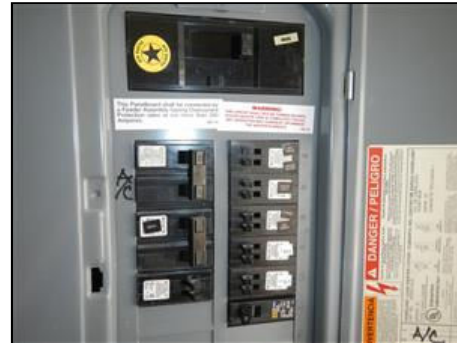
7.6 Picture 2 Sub-panel in utility room

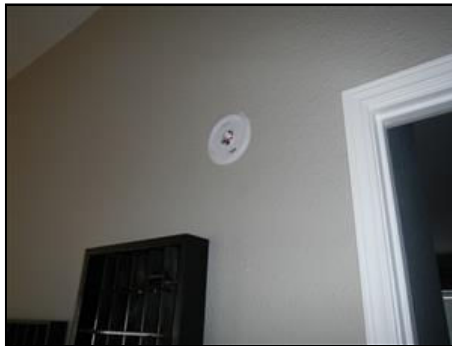
Hard-wired smoke alarms outside bedroom doors have been removed, and a battery-powered combination alarm installed outside master bedroom door at north end. Recommend hard-wired combination alarms be installed in original locations. Smoke (and carbon monoxide) alarms are safer when they have more than one source of power.

7.7 Picture 1 Bracket for smoke alarm on south side

7.7 Recommend there be a smoke alarm in each bedroom as well as outside bedroom doors.

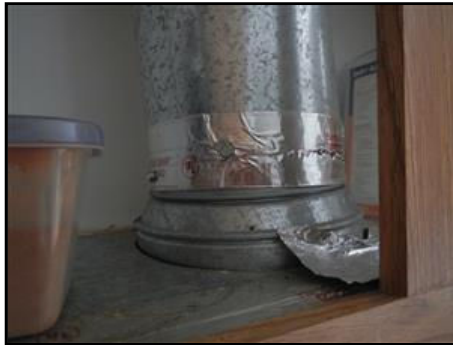
9.4 Air leaks from connection between range hood and duct; recommend re-sealing with mastic or foil-covered tape.

9.4 Picture 1 Connection of range hood with duct

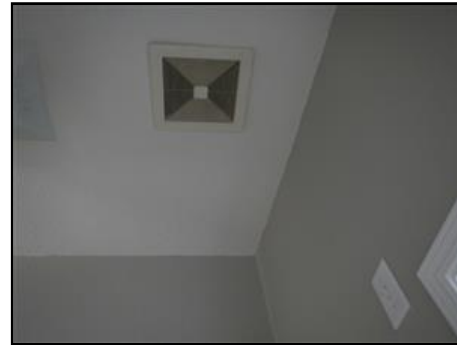
9.4 Picture 2 Whole-house fan grille

Recommend clean dust from fan grilles.

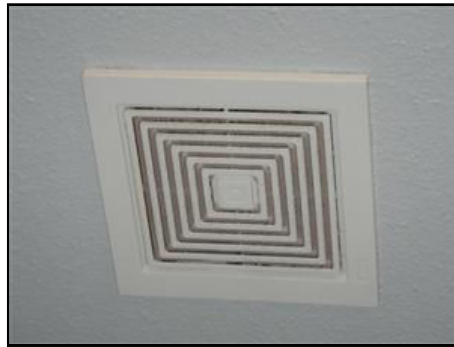
9.4 Picture 3 Bathroom fan grille

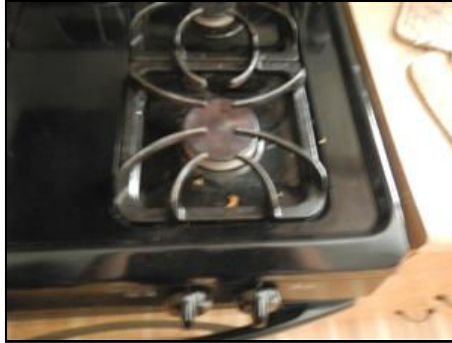
10.1 Right front burner of gas stove doesn't light from spark. Recommend service.

10.1 Picture 1 Right front range burner

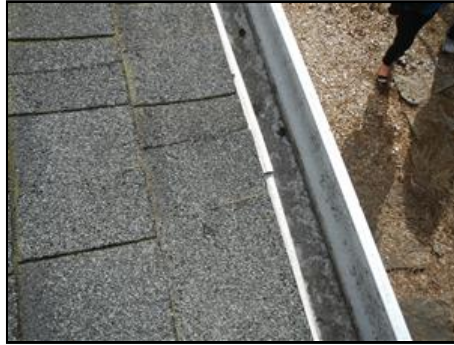
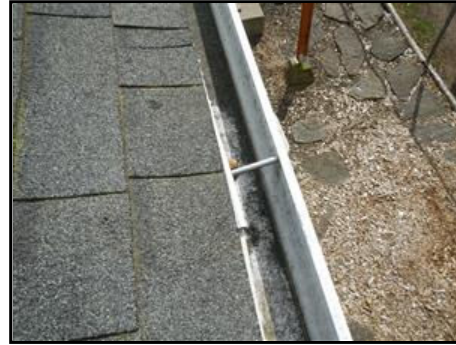
Flashing into gutters appears to be pulling away from house in a few places. Recommend this be further investigated to make sure storm water is properly directed into gutters and away from house.

1.1 Picture 1 Roof flashing in back

1.1 Picture 2 Roof flashing in back

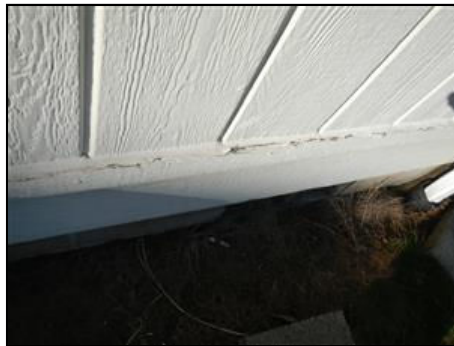
Paint peeling, sealant failing at top of some trim boards. It's important to keep siding areas maintained, especially where they're in heavy contact with rain, such as trim boards.

2.0 Picture 1 Exterior trim board

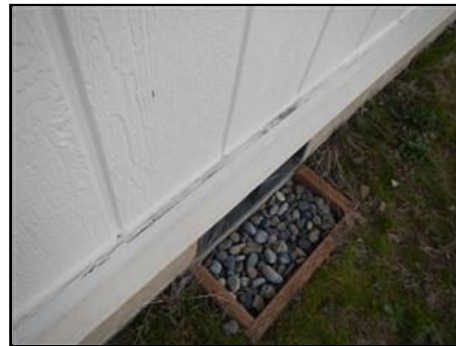
2.0 Picture 2 Paint peeling at top of trim board

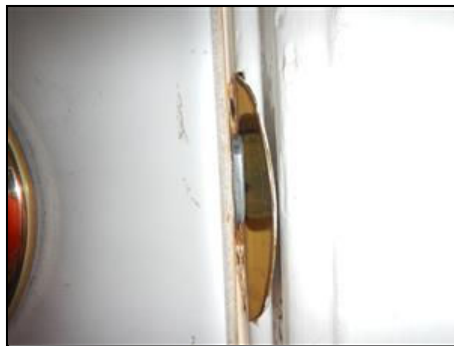
Back door deadbolt doesn't line up with hole in jamb, so cannot operate.

2.1 Picture 1 Deadbolt too high for strike plate in back door

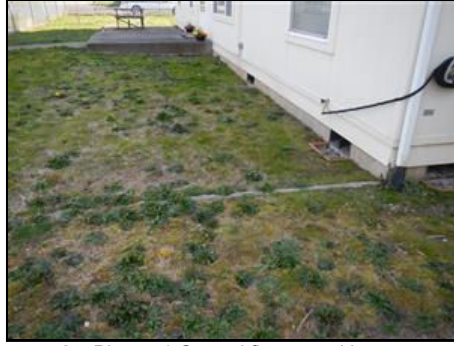
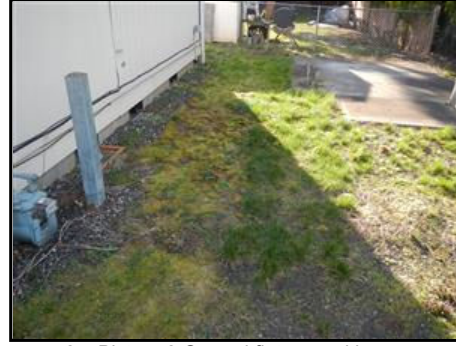
Land is flat around home. Ideally, it would fall at least 6 inches within 10 feet away from home. It appears ground moisture is entering crawl space, causing moisture damage.

2.4 Picture 1 Ground flat around home

2.4 Picture 2 Ground flat around home

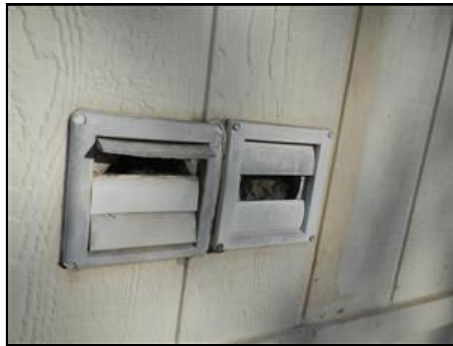
Dryer duct outlet louvers don't shut all the way, allowing some extra heat to be lost from the house. There appear to be two dryer ducts, with the one on the south plugged by insulation materials. South-side dryer duct could be closed off completely to reduce heat loss.

2.6 Picture 1 Dryer duct outlets

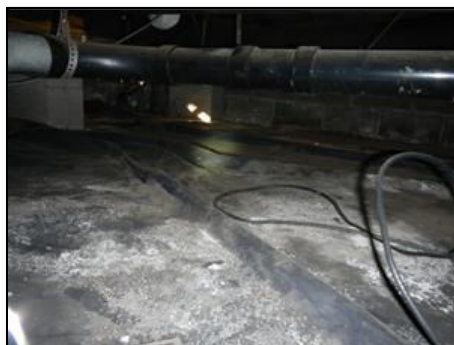
Water infiltration may be a result of site grading -- entire site, including under home, is flat. The ground under the home should be sloped away from the center, and that slope should continue to at least 10 feet from home. If the water entry is because of the lack of proper grading or a high water table at the site, perimeter drains or a sump pump could be installed to manage the water. Crawl space was dry and it had not rained in several days at time of inspection, so could not determine if there is a break in a storm water drain pipe routed through crawl space. Regular moisture under a home can cause damage and mold from the high humidity.

5.0 Picture 1 Signs of frequent water entry into crawl space

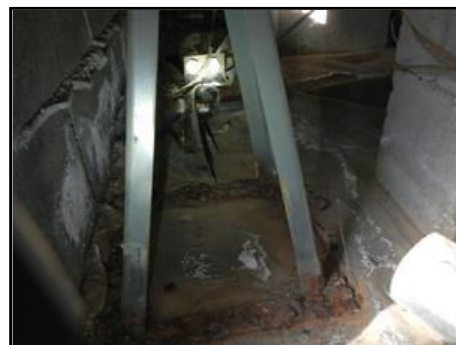
5.0 Picture 2 Rusted base of steel recessed perimeter pier

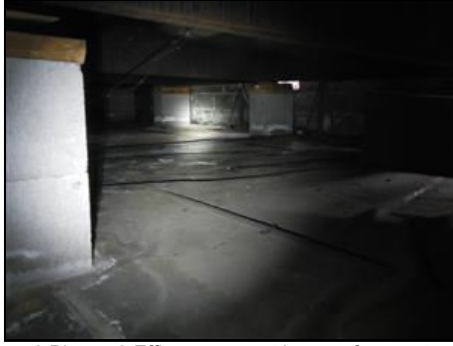
5.0 Picture 3 Efflorescence at bases of concrete block piers

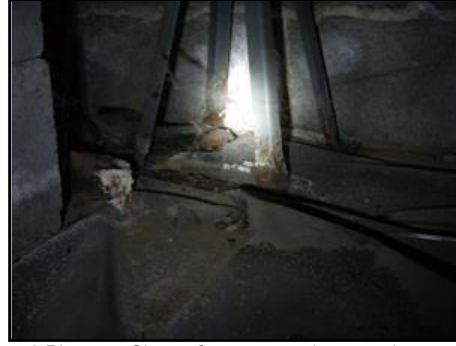
5.0 Picture 4 Signs of water entry into crawl space

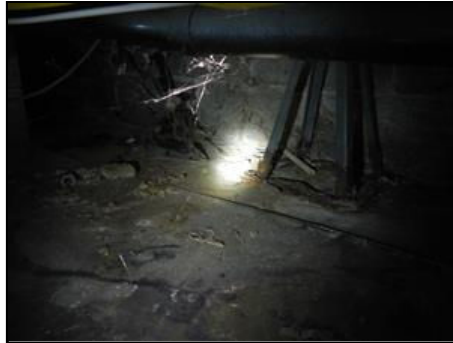
Note: Structure is tied down to earth with ground anchors.

5.0 Picture 5 Ground anchor to left of recessed perimeter pier

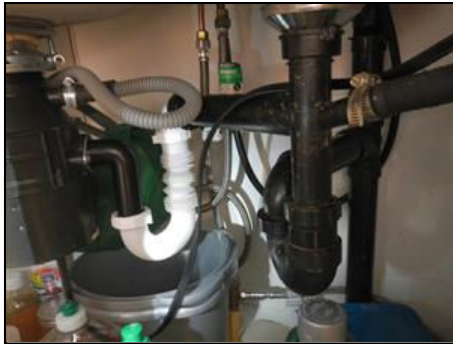
6.0 Picture 1

Garbage disposal not plumbed properly; dishwasher drain hose doesn't enter disposal, it's double-trapped, and it has a corrugated waste pipe. Recommend repair by licensed plumbing contractor.

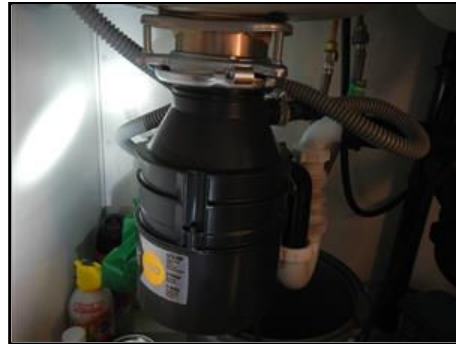
6.0 Picture 2 Garbage disposal with capped-off dishwasher drain hose attached

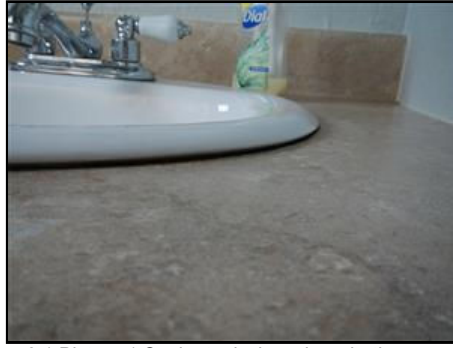
Recommend sealant between bathroom sinks and countertop so water doesn't deteriorate counters.

6.1 Picture 1 Sealant missing where bathroom sink meets counter

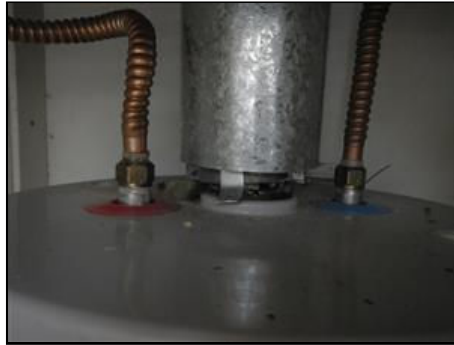
6.2 Picture 1 Hot water heater flue not attached

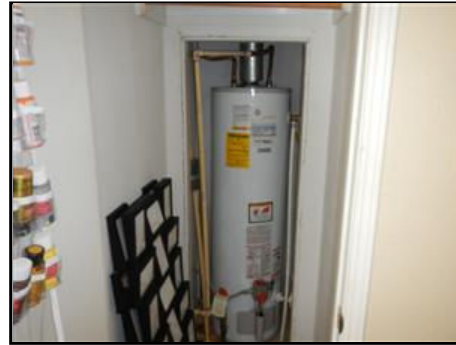
Gas water heater is in concealed alcove in closet in NW room. There is not enough combustion air provided. Recommend evaluation and service by HVAC contractor.

6.2 Picture 2 Water heater in alcove inside closet

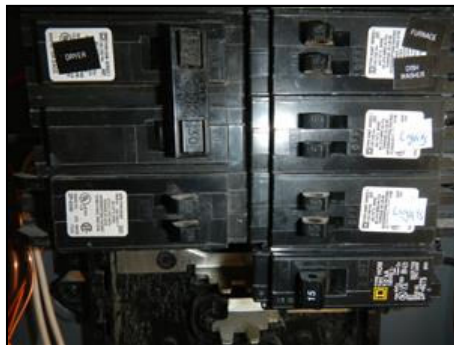
Label missing for newer 15-amp breaker in lower-right corner of sub-panel inside home.

7.1 Picture 1 No identification for breaker in lower right

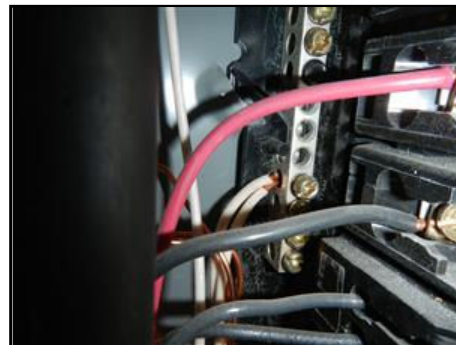
Two neutral wires connected to same lug in neutral bus bar; should be only 1 wire in each lug.

7.1 Picture 2 2 neutral wires in same lug

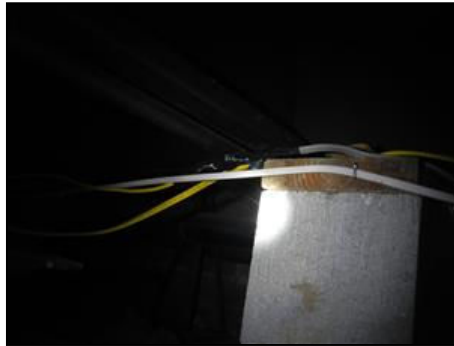
Wires spliced improperly in crawl space; yellow-colored NM cable spliced to white-colored UF cable that enters conduit to exterior at back of house. Recommend further investigation to see if this circuit is necessary; might be able to be removed.

7.2 Picture 1 Improper wire splice in crawl space

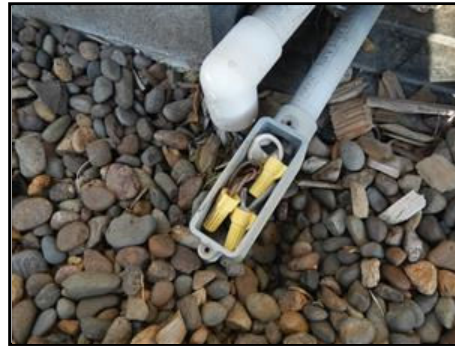
7.2 Picture 2 Conduit from crawl space at back of house (pull box cover removed)

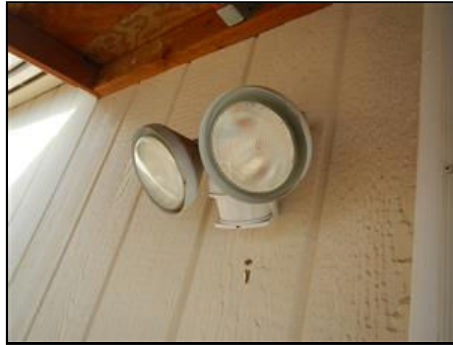
Was not able to successfully operate light at back door. May be burnt-out bulbs.

7.3 Picture 1 Back door light

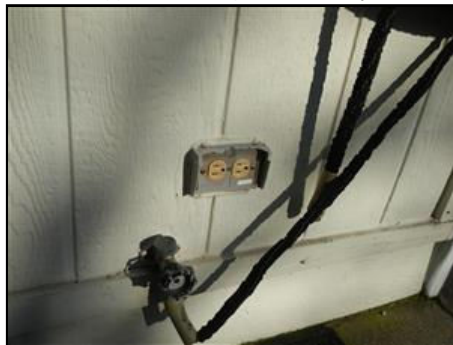
Exterior receptacle to the south of back door does not appear to have power and may lack GFCI protection. Weatherproof cover missing.

7.4 Picture 1 Receptacle to south of back door

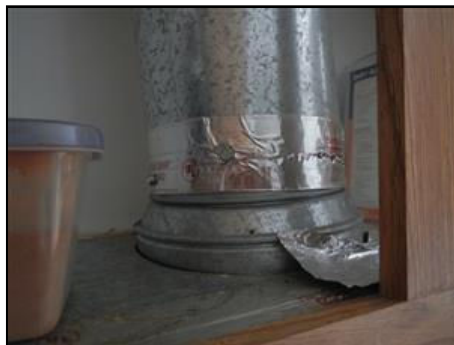
Air leaks from connection between range hood and duct; recommend re-sealing with mastic or foil-covered tape.

9.4 Picture 1 Connection of range hood with duct

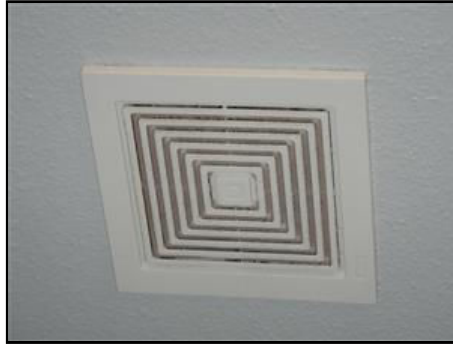
Recommend clean dust from fan grilles.

9.4 Picture 3 Bathroom fan grille

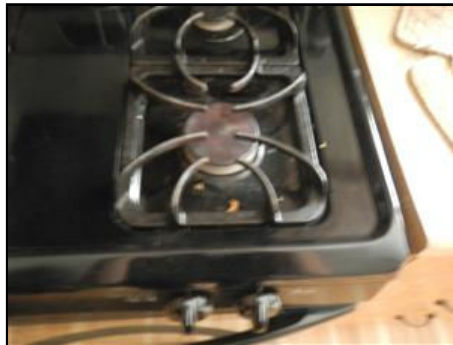
Right front burner of gas stove doesn't light from spark. Recommend service.

10.1 Picture 1 Right front range burner
